Innovative Solution : Boom Repair

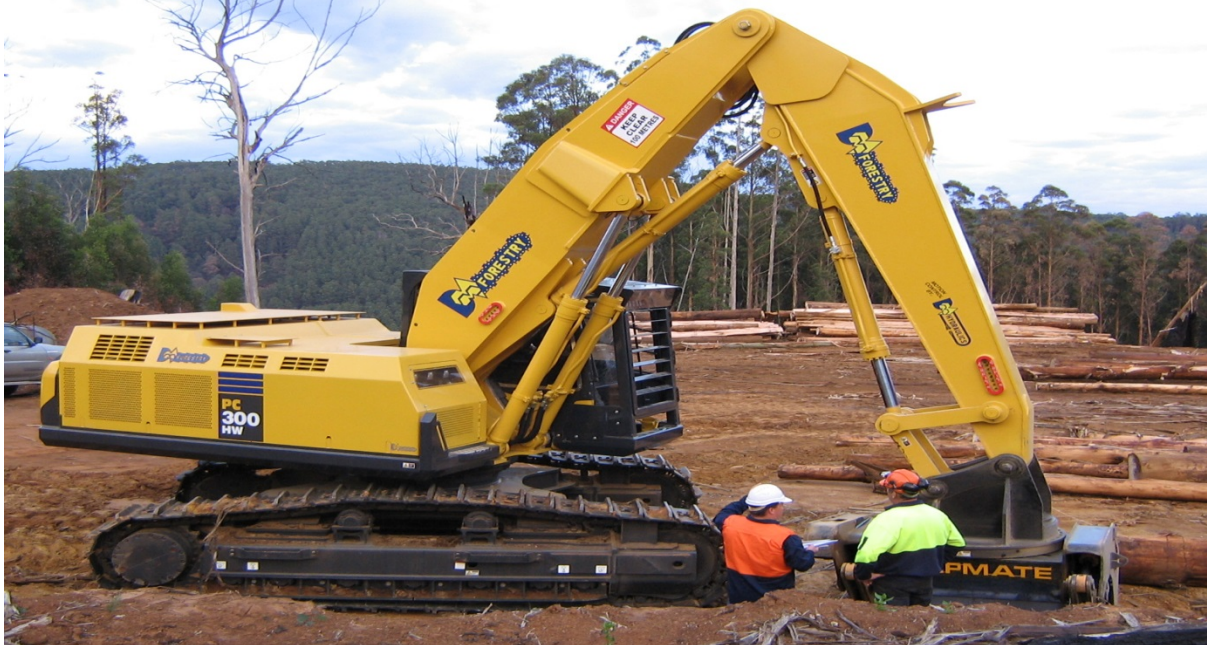
Repair a major crack failure in a boom in the shortest time frame and ensure the repair corrects the root cause of the cracking.

Detailed inspection of the crack propagation and operating load analysis were done to determine the best repair methodology. Significant field experience and sound engineering judgement was used to plan the repair process.

The DMM team was engaged to strip the boom from the machine while it was still on-site, and transport the boom to the DMM workshop. The damaged area was cut out, installation and welding of a new bush and accurate line boring completed the rebuild. The DMM team of two staff per shift worked two shifts over the weekend to meet the customer's time frame. The boom was delivered back to site and re-attached.
